MERRIMACK RIVER BASIN
HOLDEN, MASSACHUSETTS

QUINAPOXET RESERVOIR DAM
MA 00929

PHASE I INSPECTION REPORT
NATIONAL DAM INSPECTION PROGRAM

SEPTEMBER 1980

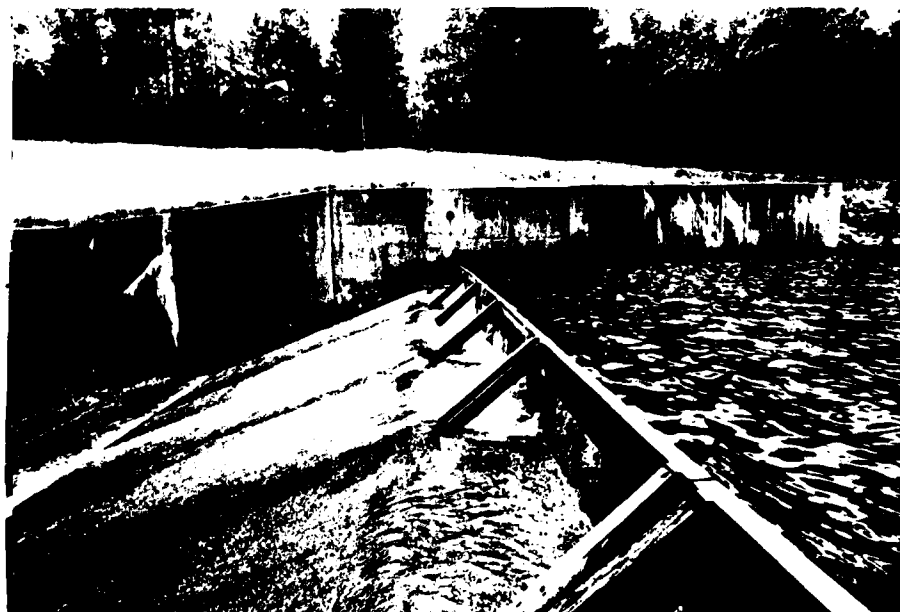
- (6) The side wall joint immediately downstream of the spillway weir at its right end is exhibiting structural distress in the form of cracking, as shown in Photo 6. The sealant at other joints in the spillway side channel, chute and stilling basin is in need of renewal.

6. VIEW OF RIGHT SIDE OF SPILLWAY.

- (2) Periodic readings should be made on any piezometers that can be restored. This data would provide a useful check of embankment and drainage system performance.
- (3) Replace the missing flashboard brace near the right end of the spillway weir.
- (4) Repair the cracked wall joint immediately downstream of the right end of the spillway weir and reseal other joints in the spillway, chute and stilling basin walls.
- (5) Establish a formal maintenance program and operational procedures for the dam.
- (6) Prepare a formal emergency procedures plan and warning system in cooperation with downstream officials and institute a program of biennial technical inspections.

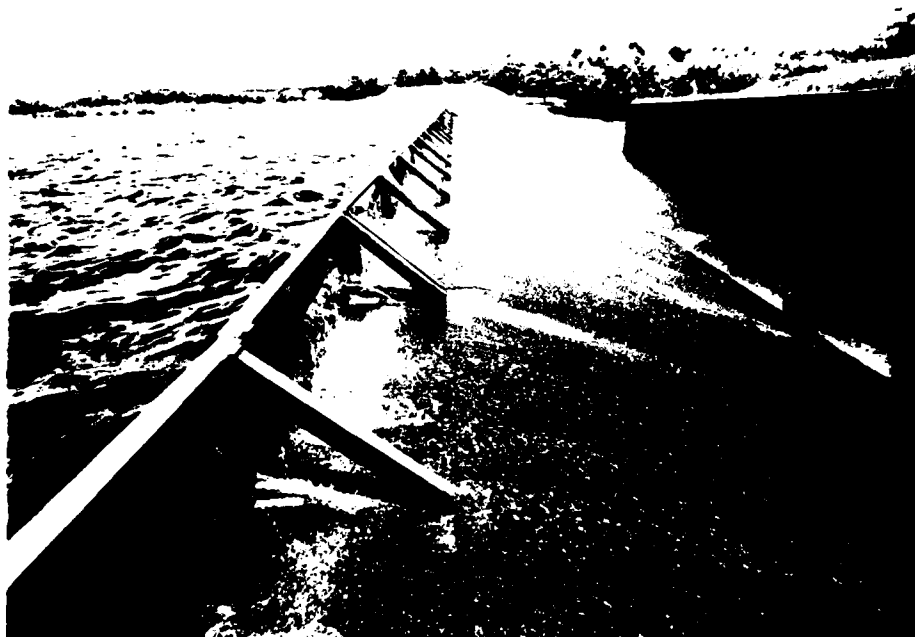
- (4) No piezometers were found on the dam embankment.
 - (5) One of the flashboard braces near the right end of the spillway is missing as shown in the foreground of Photo 7.

7. VIEW OF SPILLWAY AND SPILLWAY LEFT ABUTMENT.

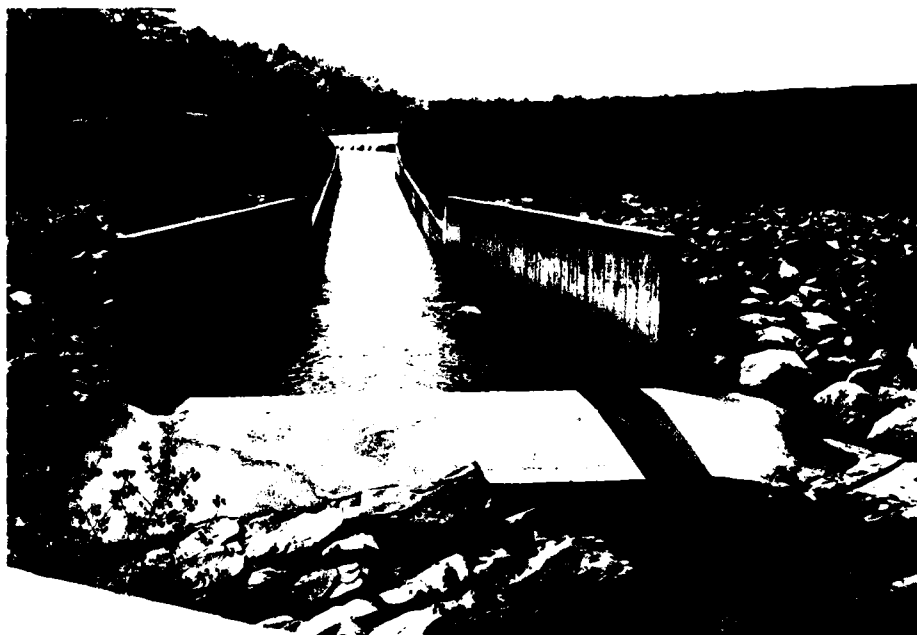
- b. Dam - The dam and spillway, Photos 1, 8 and 9 appear to be in generally good condition, based on the visual site examination. No evidence of embankment settlement, lateral movement or other major deficiencies was observed. The following specific items were noted:

9. VIEW OF SPILLWAY DOWNSTREAM CHANNEL FROM PRINCETON STREET BRIDGE. NOTE SILL AND V-NOTCH DRAIN IN FOREGROUND.
